## Submerged Burlap Strips Aided Rehabilitation of Disturbed Semiarid Sites in Colorado and New Mexico<sup>1</sup>

Burchard H. Heede<sup>2</sup>

Two planting sites with narrow submerged burlap strips showed 14 times less soil loss than control sites without burlap. Gullies and deep rills need to be reshaped to gentle swales before burlap is installed. Plant cover should become established before burlap disintegrates—about 5 years.

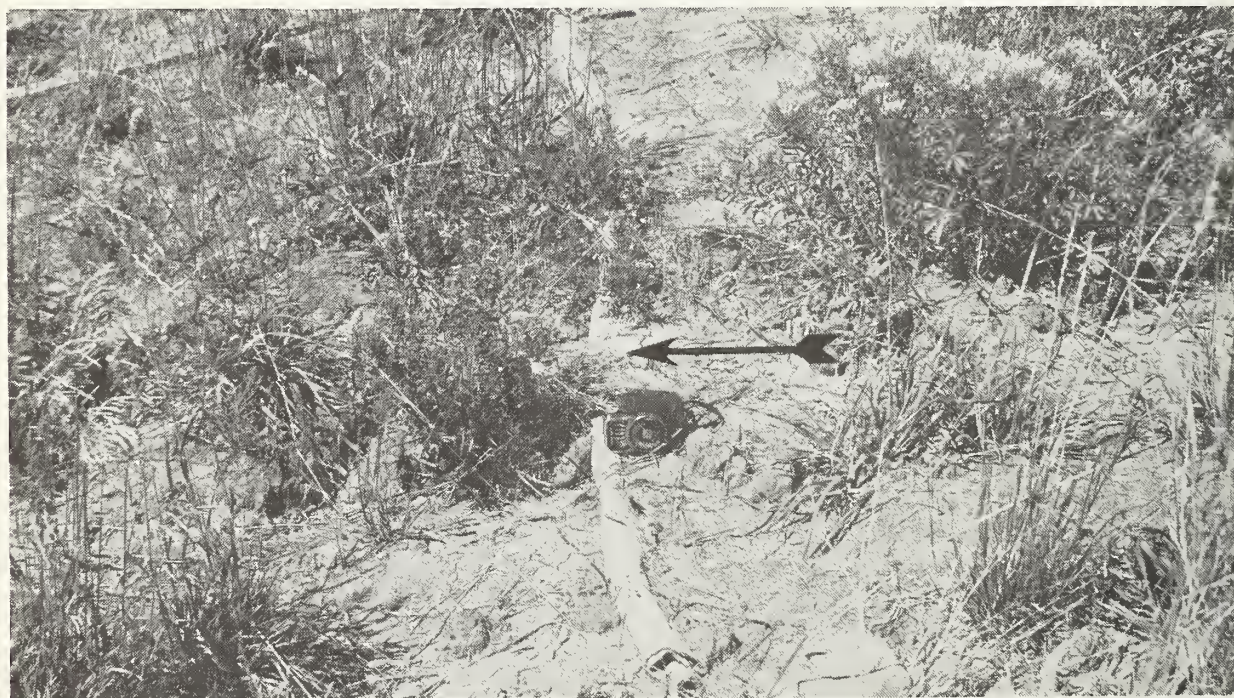
Figure 1.—Looking at a submerged burlap strip installed on waterway No. 6 on Alkali Creek watershed. Arrow indicates the direction of flow.

To install the burlap strips, we made 10-inch-deep furrows on the contour, with a moldboard plow. Burlap sheets, 10 feet by 10 feet, were folded into strips 12 inches wide and 10 layers thick. The strips were placed on the downhill side of the furrows, leaving 2 to 3 inches of burlap protruding above the ground surface. The furrows were then filled with the excavated soil, and the disturbed areas seeded to perennial grasses. Installation of 316 feet of burlap strips along with broadcast seeding took 8 hours for one man and a team of horses.

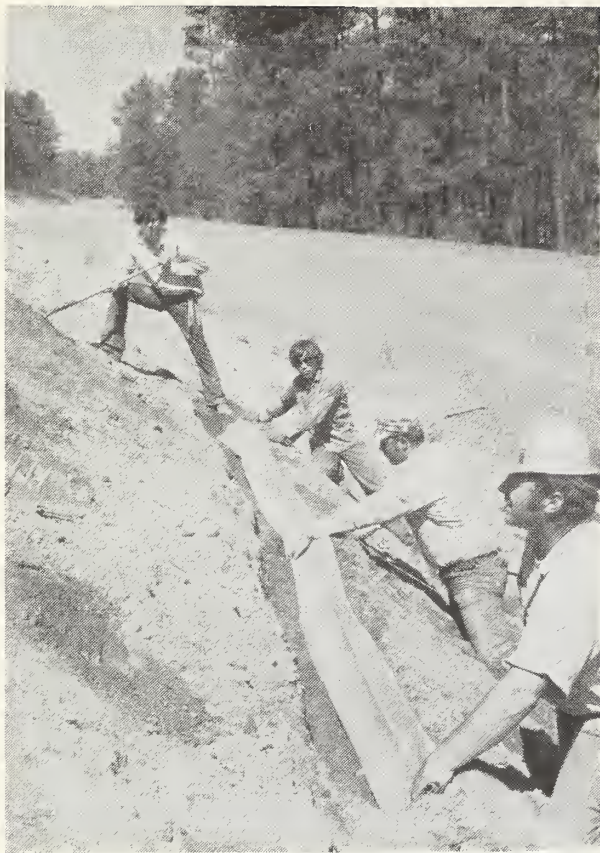
Figure 2.—Placement of burlap strip into trench of road-cut slope on the Gila National Forest.

The burlap strips on the first plot were installed in hand-dug trenches 10 inches deep and as narrow as the tools permitted. Work started at the top of the bank and proceeded downslope. Excavated material was thrown above the trench. Burlap obtained in 4-foot wide rolls, was cut into sheets 20 feet long and folded into four-layer strips 1 foot wide. A burlap strip was placed against the vertical downhill wall of the trench so that about 2 inches of burlap protruded above the original slope surface (fig. 2). Then the excavation was filled and compacted by foot and hand tools. Western wheatgrass transplants were then planted above and adjacent to the strips (fig. 3).

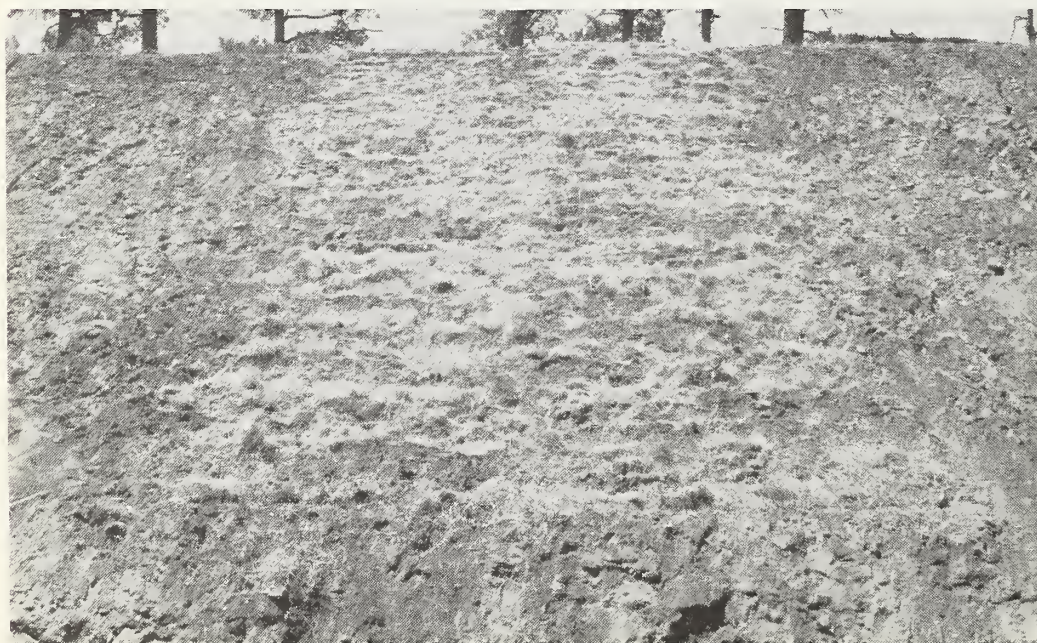
Figure 3.—The Gila burlap plot after planting. Straw mulch covers the transplants for protection against intense heating and excessive soil moisture depletion.

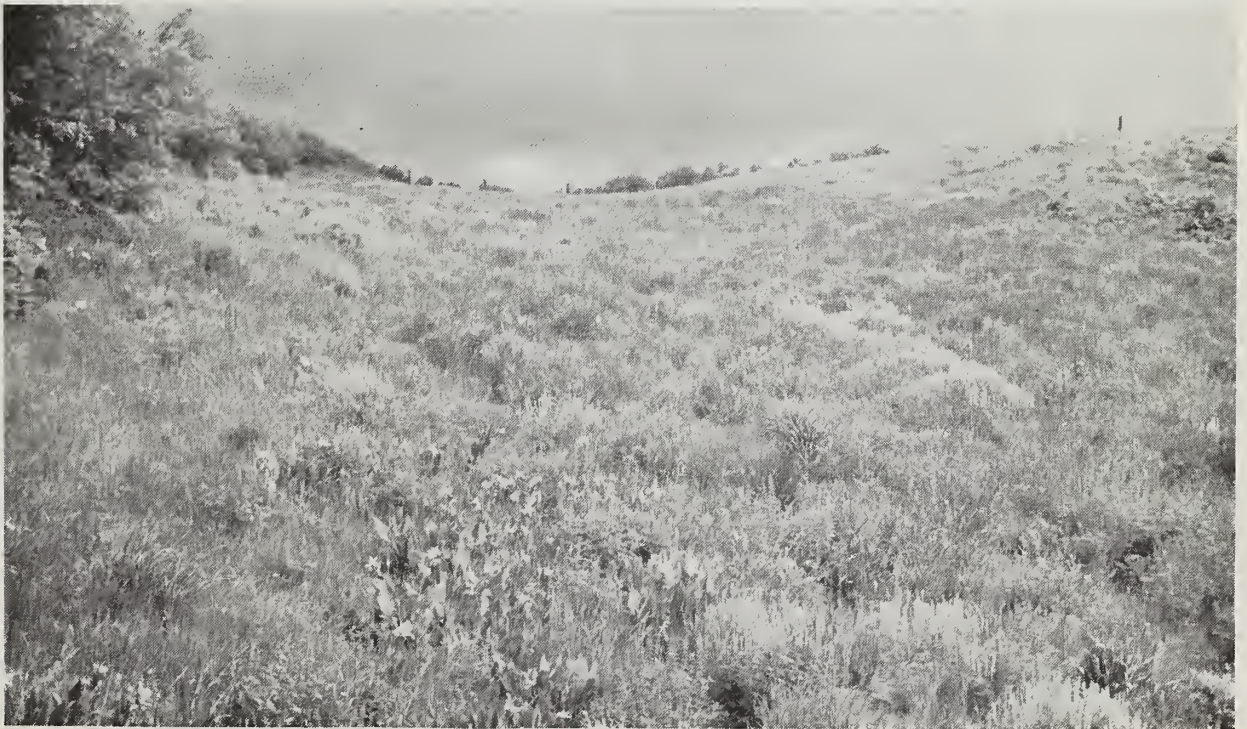
Figure 5.—Upstream view of Alkali Creek waterway No. 6, 2 years after treatment.

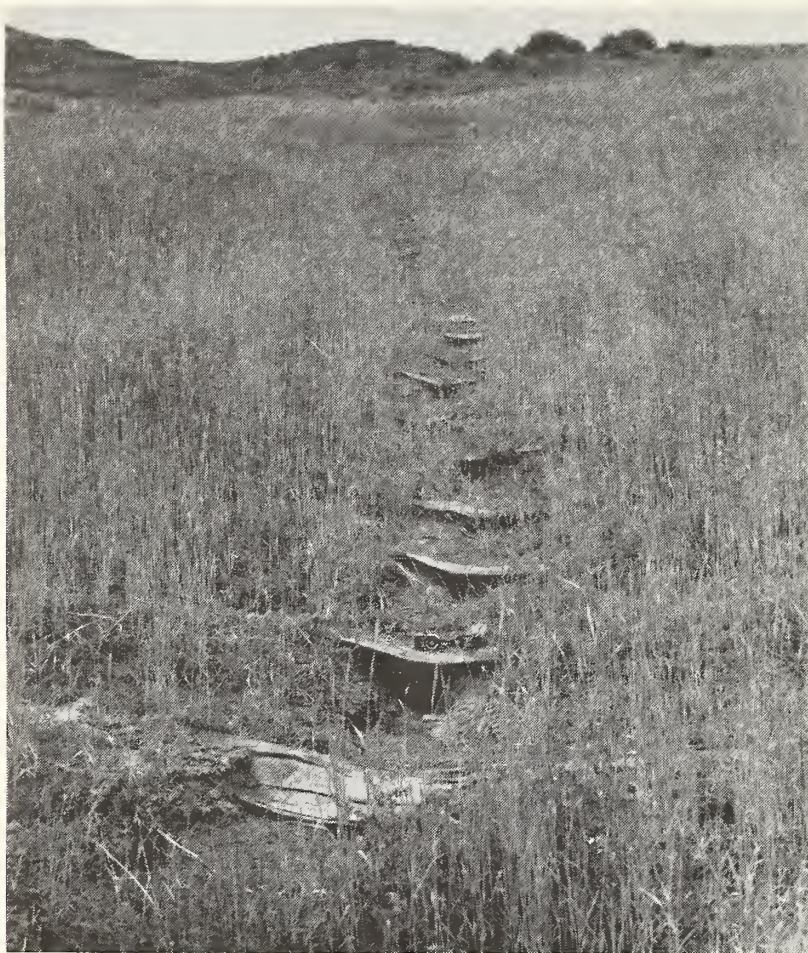
Figure 6.—Looking upstream on middle reach of Alkali Creek waterway No. 18, where V-shaped waterway cross sections caused concentrations of flow.

On the Alkali Creek watershed, the submerged strips lasted and functioned for 5 to 6 years before they disintegrated and became ineffective. Remnants of the strips remain, however, 12 years after installation (fig. 4). It took 2 to 3 years for an effective perennial plant cover to become established. During the vulnerable time, the strips provided much needed stability to the waterways (fig. 5). Yet, on one reach of waterway 18, plants and burlap strips together did not stop the development of a major rill. The V-type

cross section of the waterway in this reach, forced on the construction by a constriction of the valley bottom, did not allow adequate water spreading and flow concentrations took place. After 3 years, the burlap strips formed small check dams, which caused the flows to drop on unprotected ground surface below, where scour holes developed (fig. 6). Now a continuous channel up to 8 inches deep exists in this reach, and control by loose rock is planned.

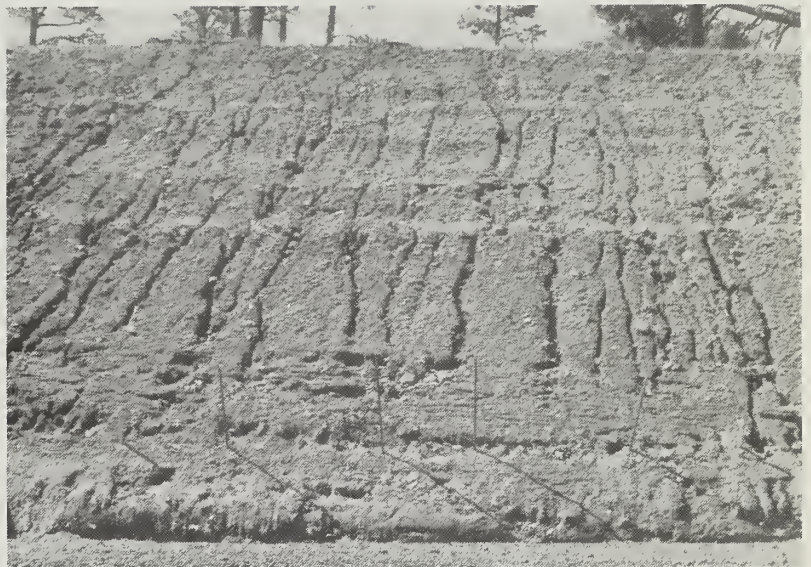
Figure 7.—The Gila control plot (no treatment) 1 year after study began. Note that continuous rills and gullies dissect the slope. The horizontal striations are duripan horizons.

The October 1973 resurvey of the road-cut slope showed that, in spite of heavy soil disturbances on the plot with transplants and burlap, the differences in net erosion between it and the undisturbed control plot were nil for practical purposes (table 1). This result became obvious within a year after treatment (figs. 7, 8).

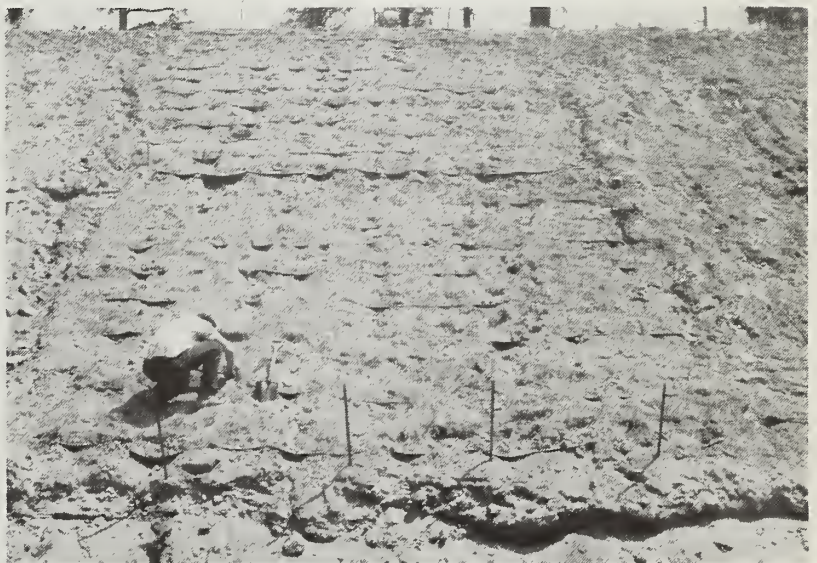
Figure 8.—The road-cut burlap plot 1 year after treatment. Continuous rills and gullies did not develop. Stakes in foreground and on crest of slope are transect markers.
